SIMULATED SOLAR HEAT TEST OF MUST WARD CONTAINERS

September 18, 1970

J. W. Grimes, W. J. Mulroy and T. W. Reichard
Building Research Division
Institute for Applied Technology

U. S. Army Natick Laboratories
Natick, Massachusetts

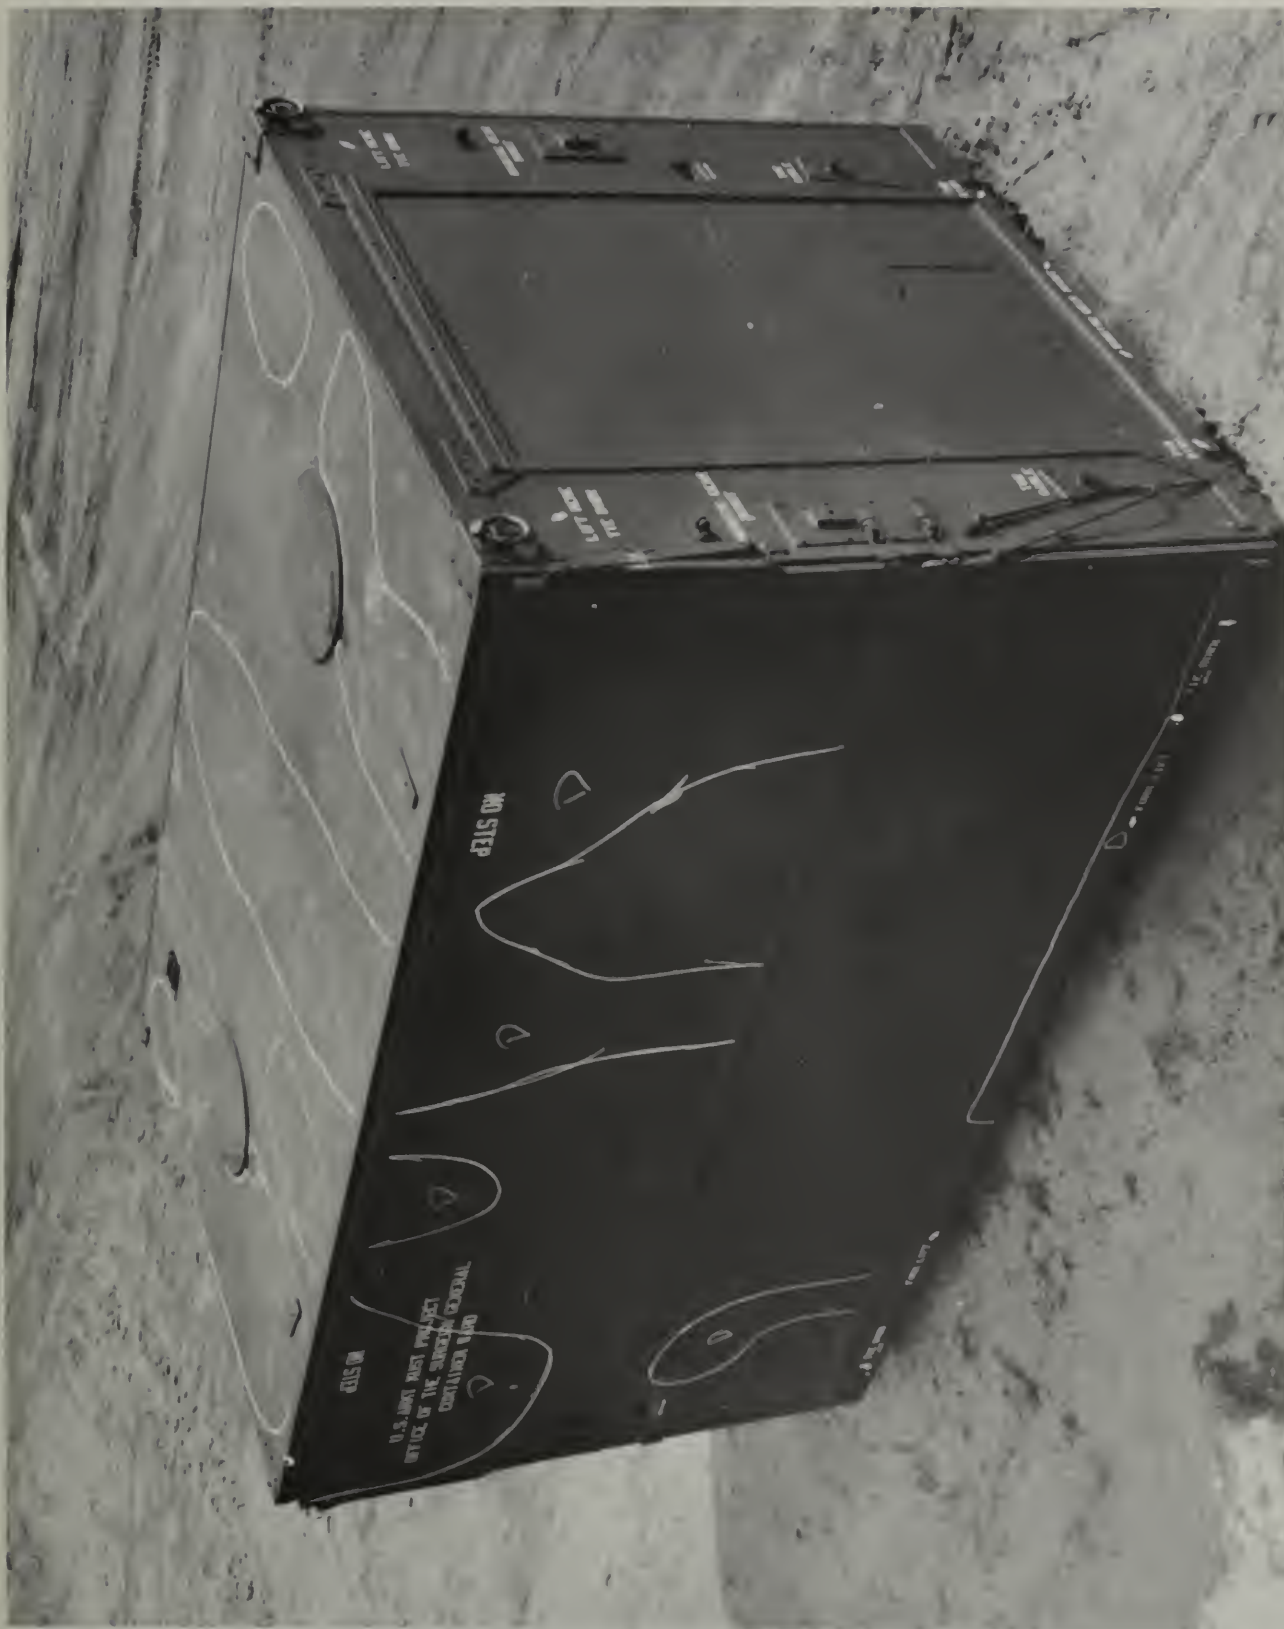
The Army has procured a number of these Ward Containers which have exhibited delamination in the sandwich panels shortly after acceptance. Figure 1 is a picture of a Ward Container found to be delaminated after delivery to the Atlanta Army Depot. The chalk marks outline the areas found, by tapping, to be delaminated. It was suggested that solar heating of the exterior facings probably triggered the delamination of poorly bonded panels in these containers, as shown in figure 2.

Figure 1. Overall view of a typical delaminated Ward Container. Chalk marks outline the delaminated areas as determined by tapping (NLABS Photo).

3. No delamination was observed on the fixed roof of the prototype ward (Ward A) whereas extensive delamination (20%) occurred on the fixed roof of the production sample (Ward B)
4. Delamination of the fixed roof of the production sample, Ward B, tended to start at the roof vents and spread progressively towards the roof edges with the daily temperature cycles. This differs from the pattern of delamination indicated on the ward container of figure 1.

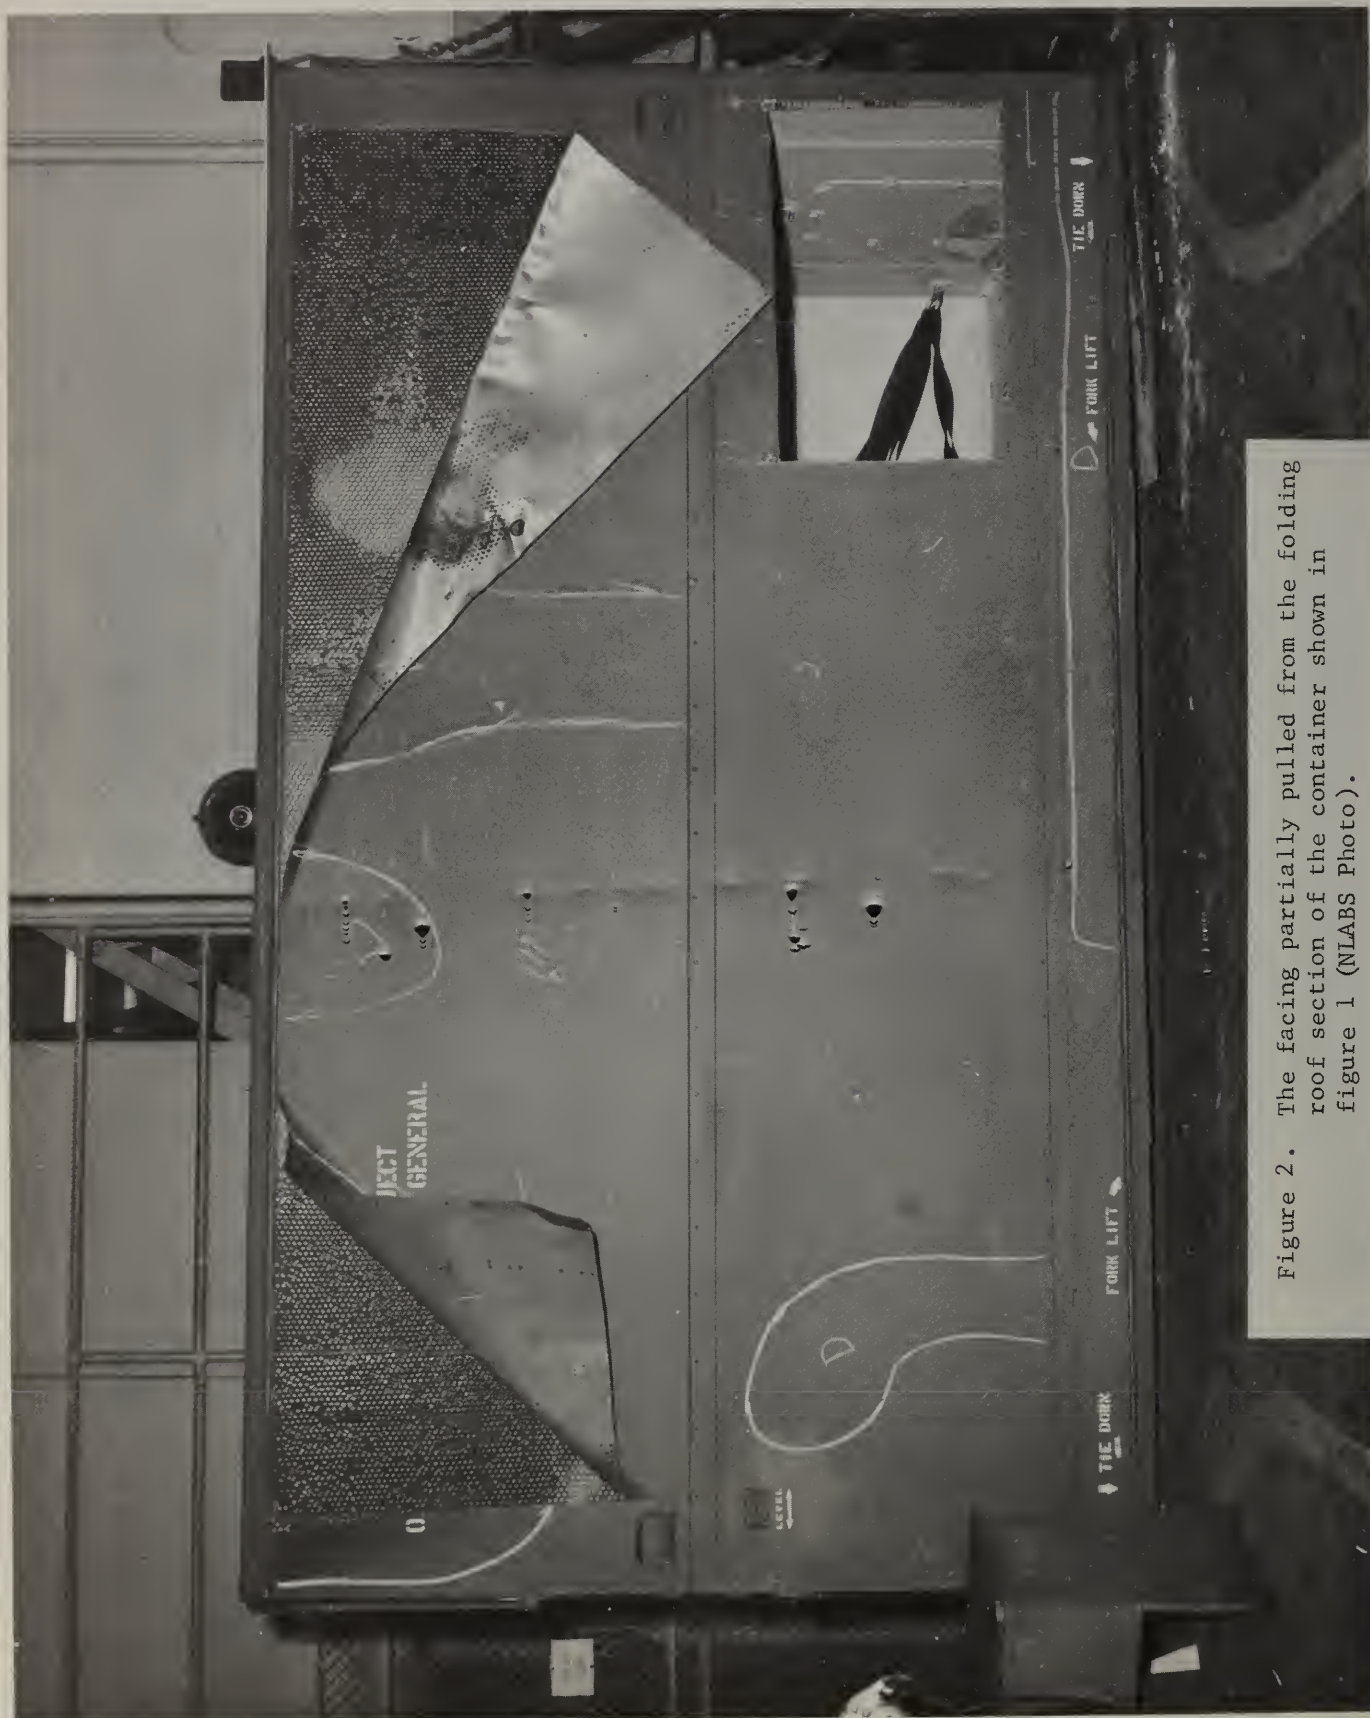
Figure 2. The facing partially pulled from the folding roof section of the container shown in figure 1 (NIABS Photo).

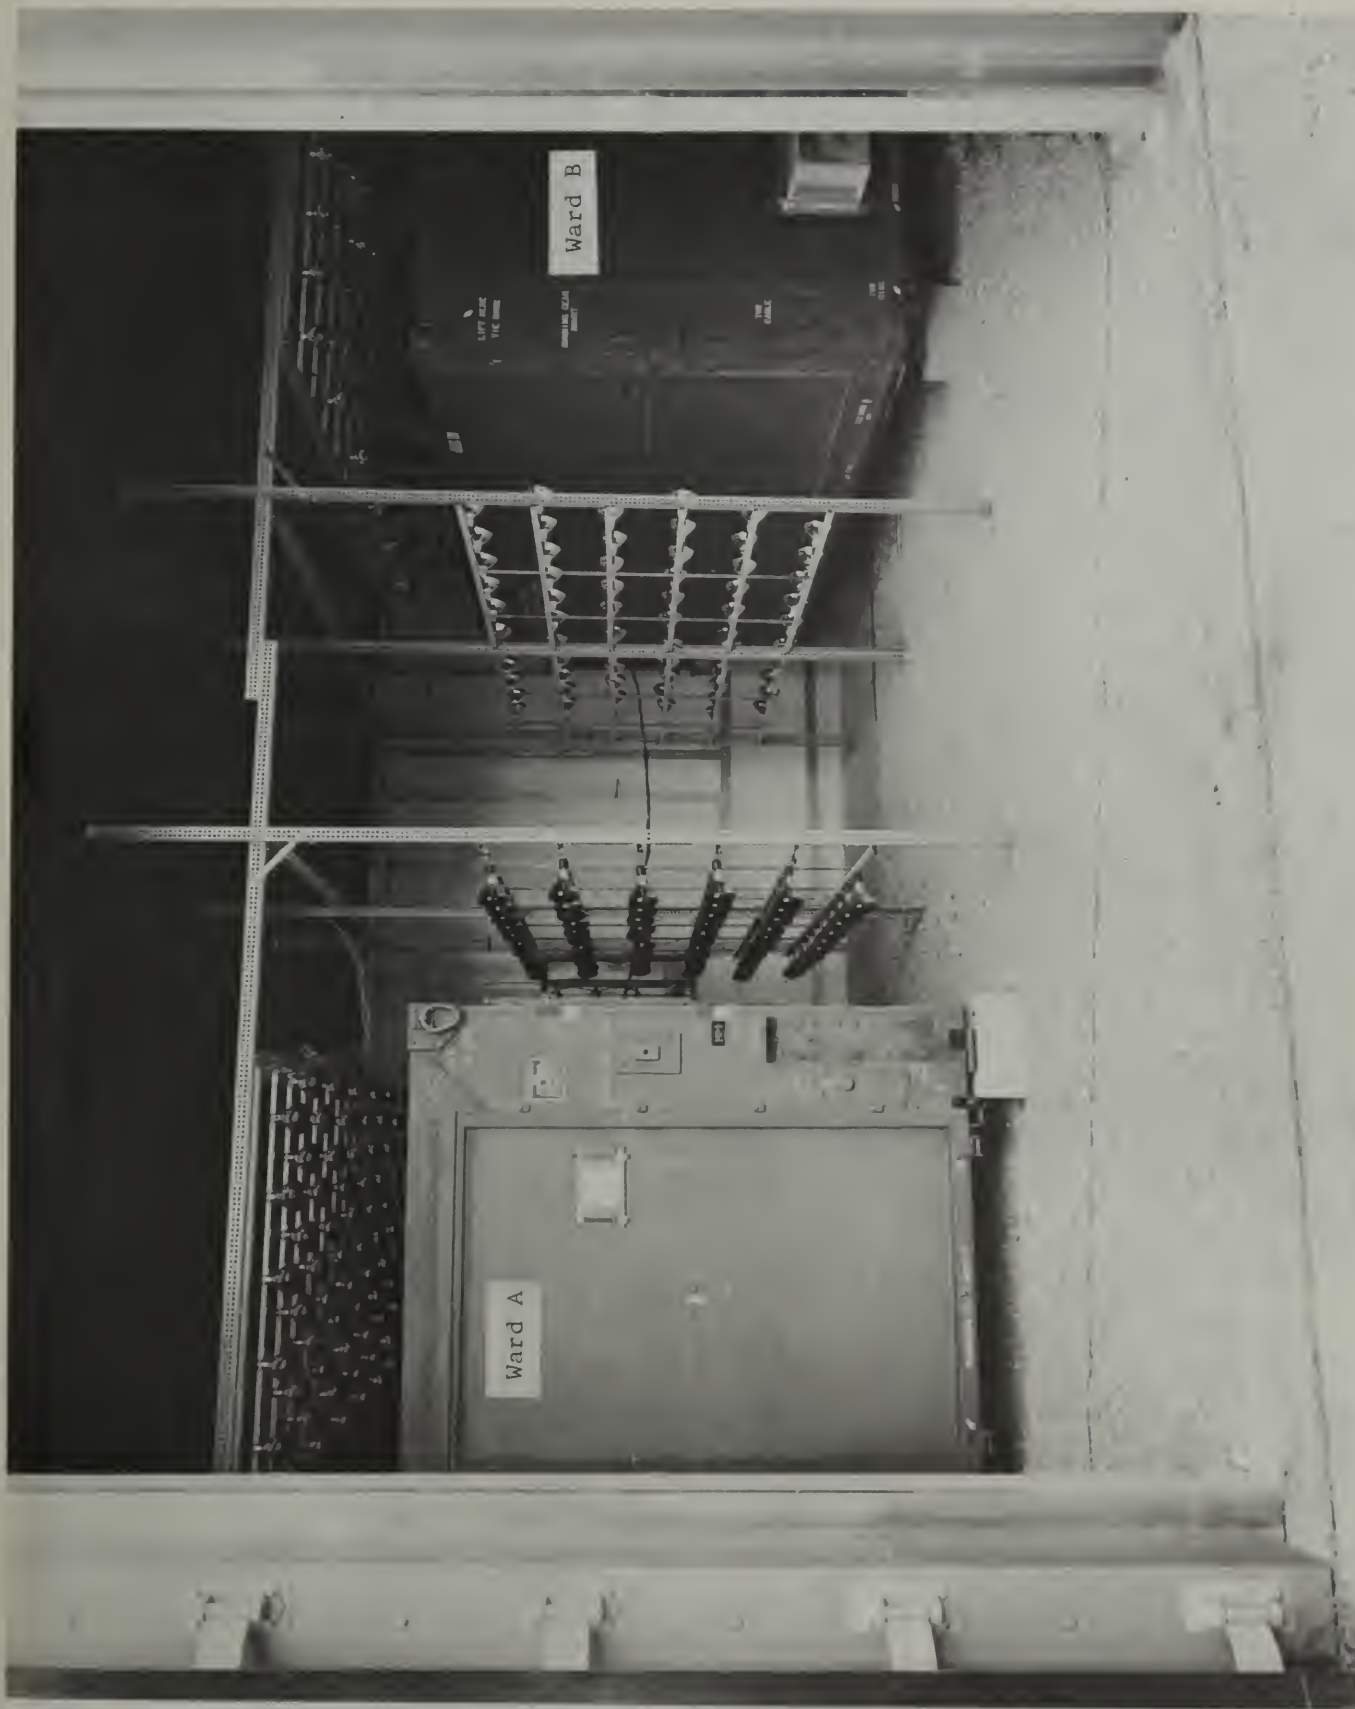
Two Ward Containers, supplied by Natick Laboratories, were tested. The two wards were of slightly different construction and will be referred to in this report as Ward A, fig. 3 and 4, and Ward B, fig. 3 and 5. The nominal size of each ward was 7 ft high x 7 ft wide x 13 ft long.

Figure 3 shows installation of Ward B and Ward A (left to right in picture) as they were tested in the environmental chamber.

Figure 3. Overall view of the two test wards in the test chamber.

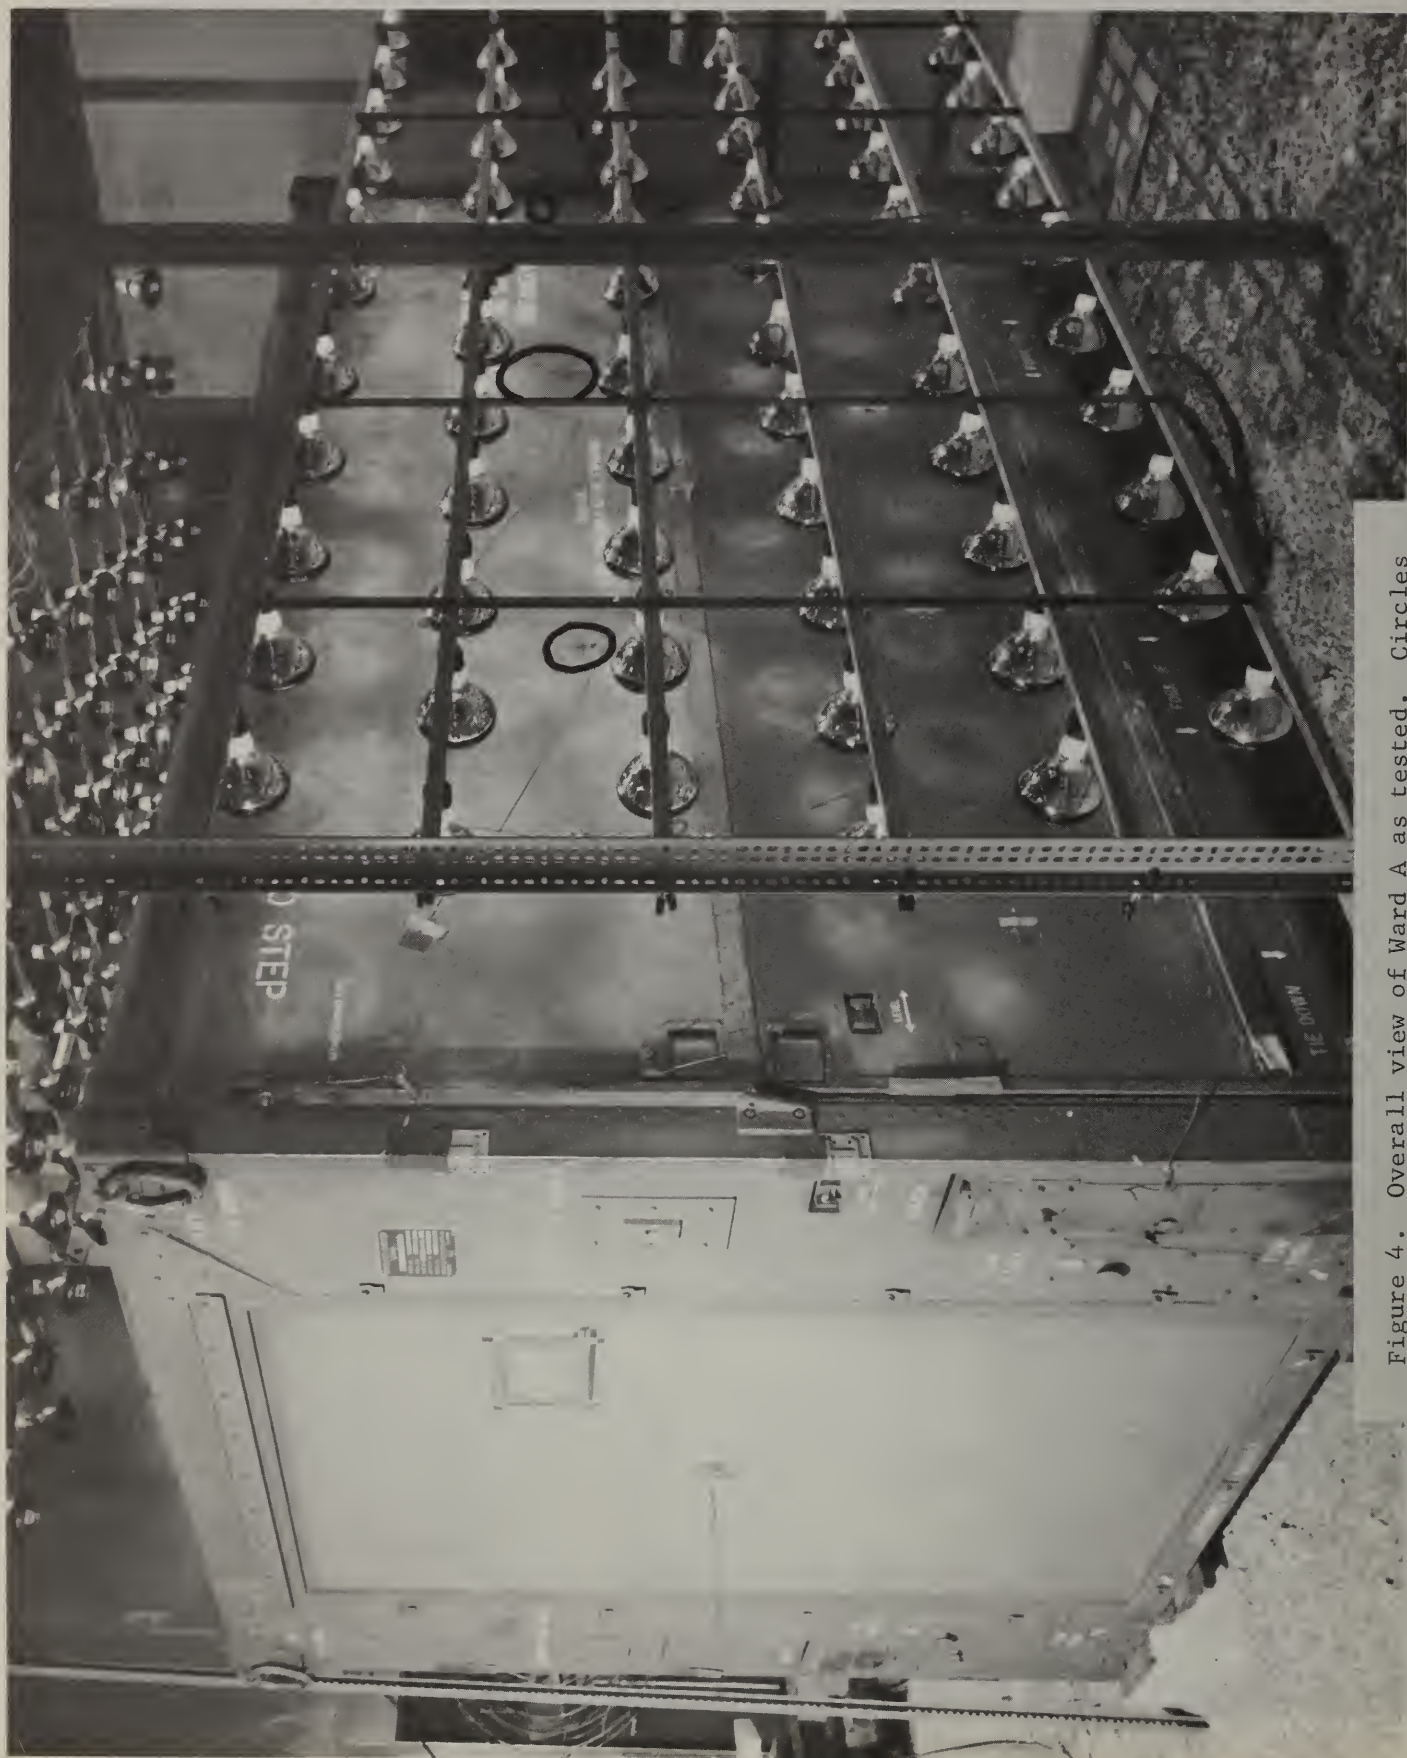
Upon receipt the two wards were tap tested to locate delaminated areas. None were found on Ward B. Two areas were found on the folding roof panel of Ward A. They were circled and dated 6/29 with a marking pen (fig. 4, 8, 9).

Figure 4. Overall view of Ward A as tested. Circles on folding roof section indicate areas found to be delaminated.

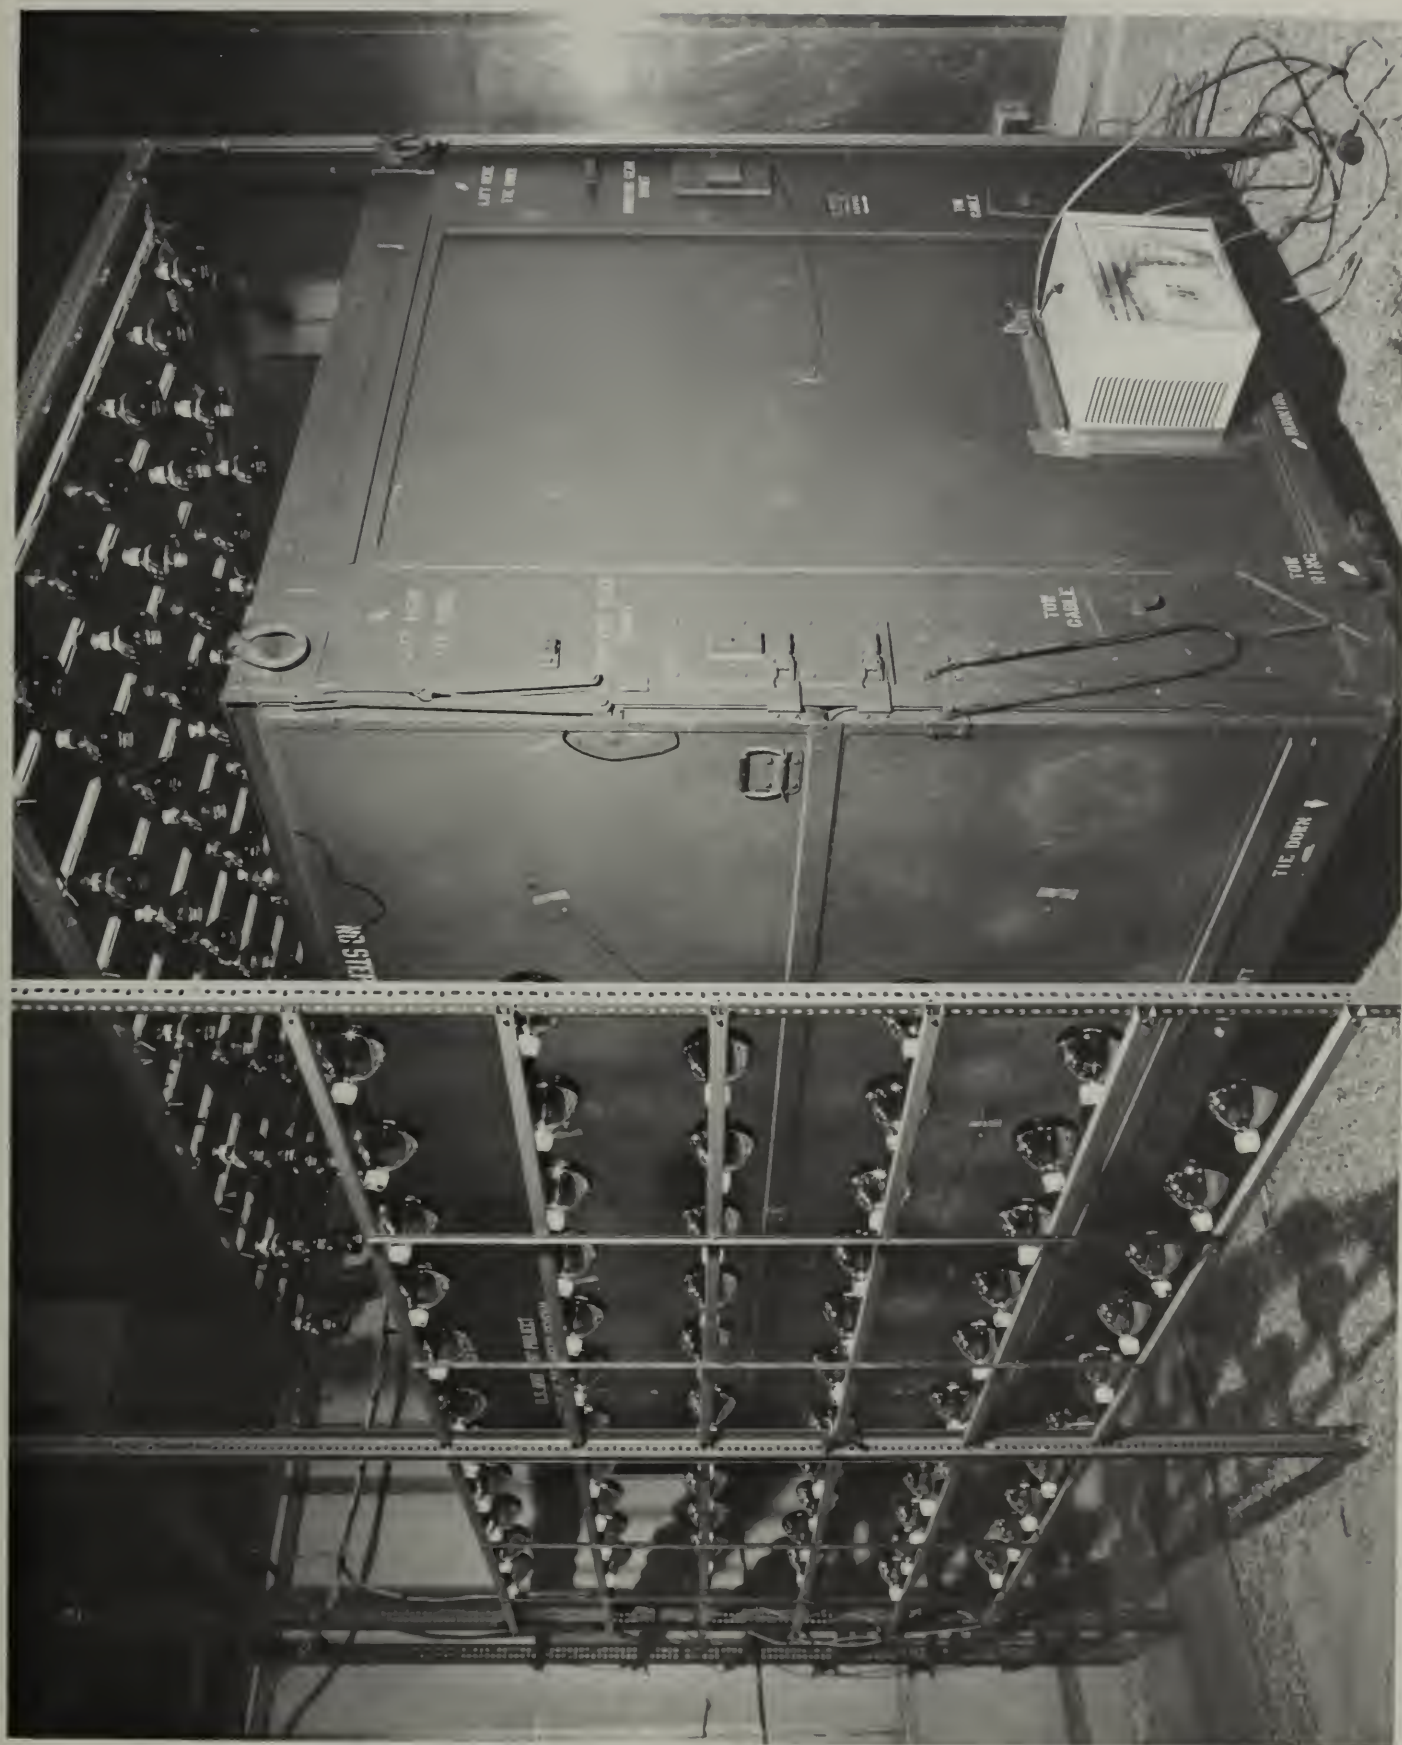
Figure 5. Overall view of Ward B as tested.

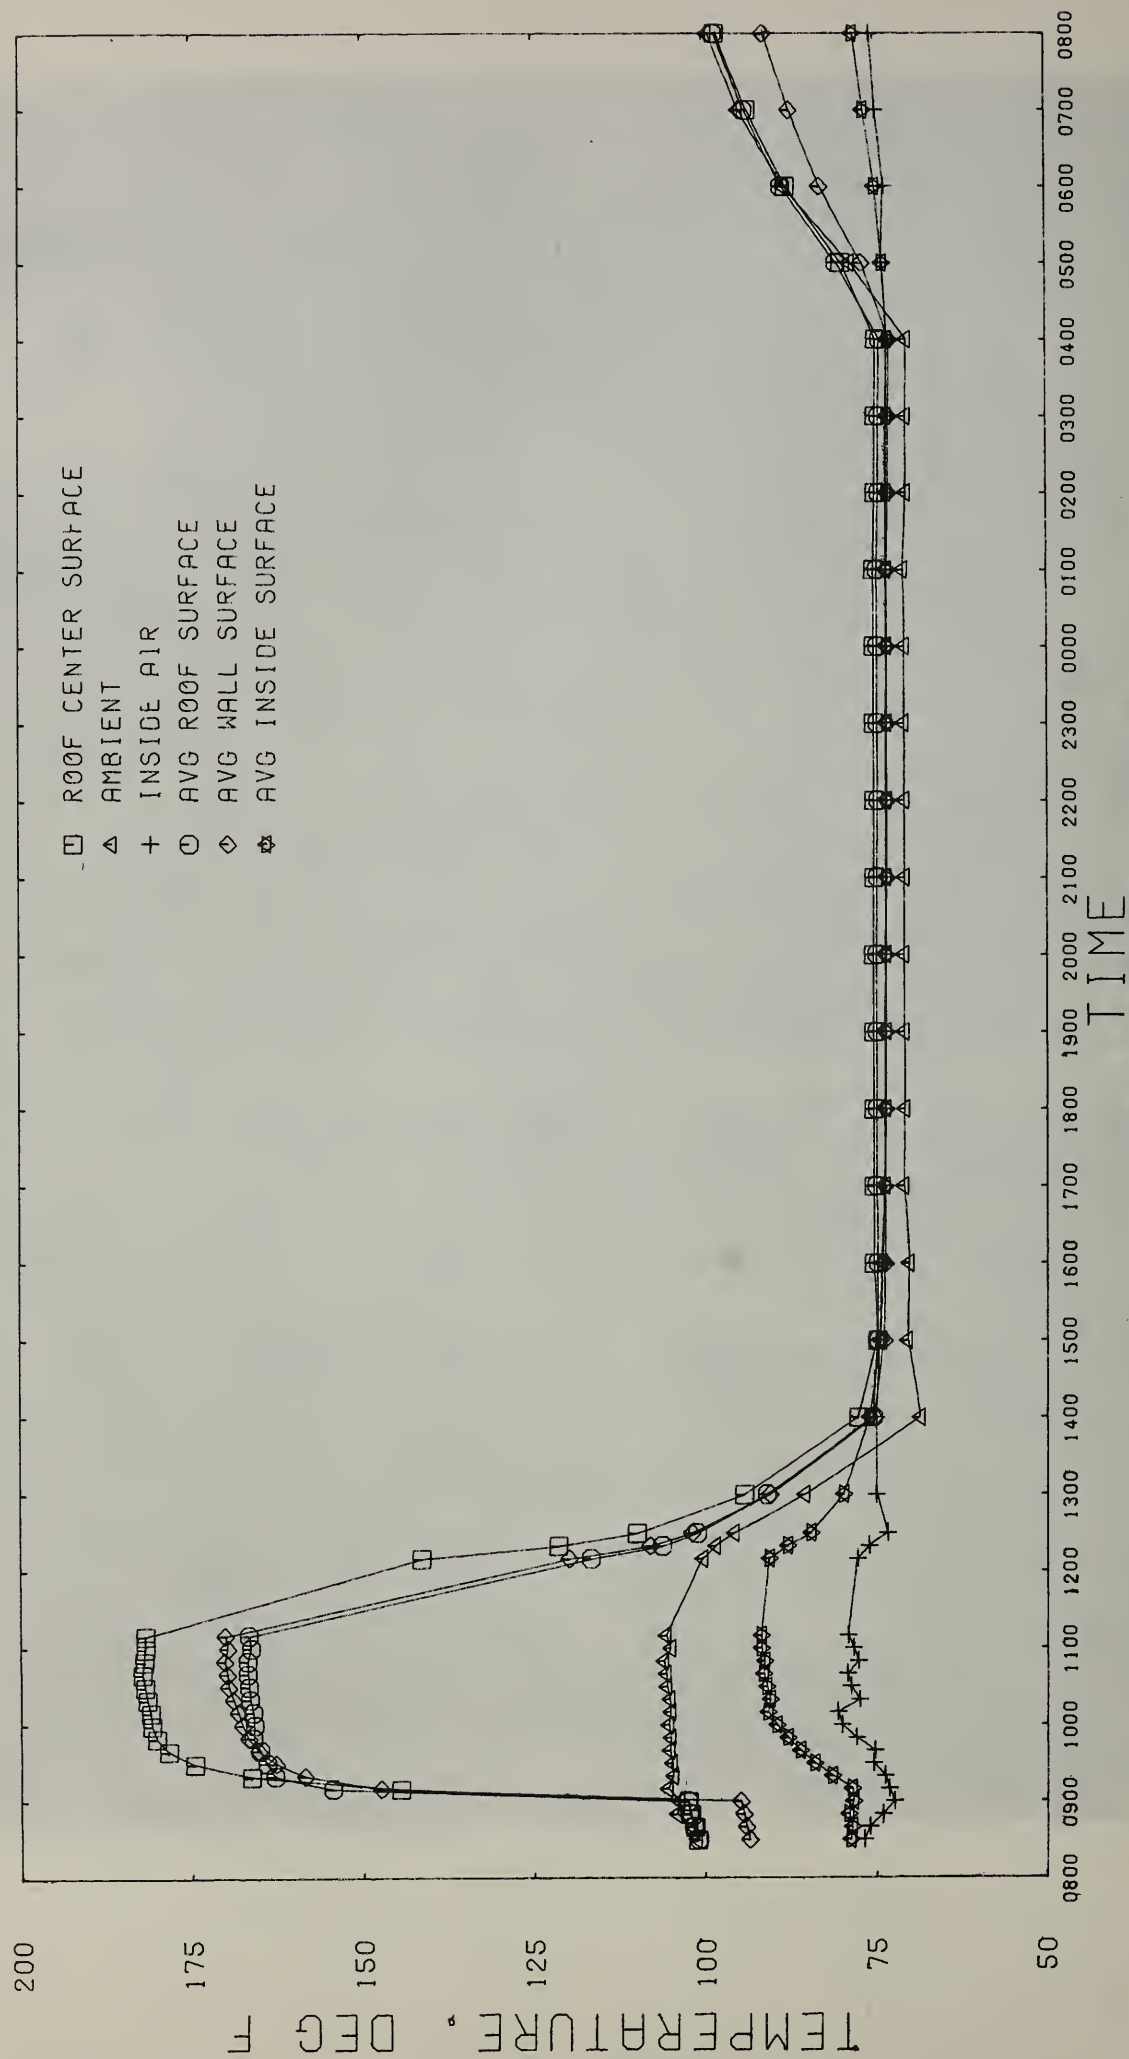
14 JULY, 1970 WARD A

Testing under controlled cyclic conditions was then begun. Fig. 6 and 7 show the time-temperature data on the two wards for a typical cycle. Testing was continued for six of these cycles (July 14, 15, 16, 17, 21, and 22). During the low temperature portion of each daily cycle a tapping test was performed, the new boundaries for delamination areas were marked, and the date was written in the newly delaminated areas. The results of these tap tests are shown in figures 4, 5 and 8 through 15. Table 1 lists the total areas of these individual delaminations.

Figure 6. Typical time-temperature data for one cycle on Ward A.

Further investigation would be desirable to determine the heat leakage of the two wards. The production sample required two cooling coils in addition to the 5000 Btu/hr package unit for cooling but the prototype required only one cooling coil. This indicates that there was a performance difference between the two samples in cooling load. This indication is supported by the interior skin temperature data shown on figure 6 and 7.

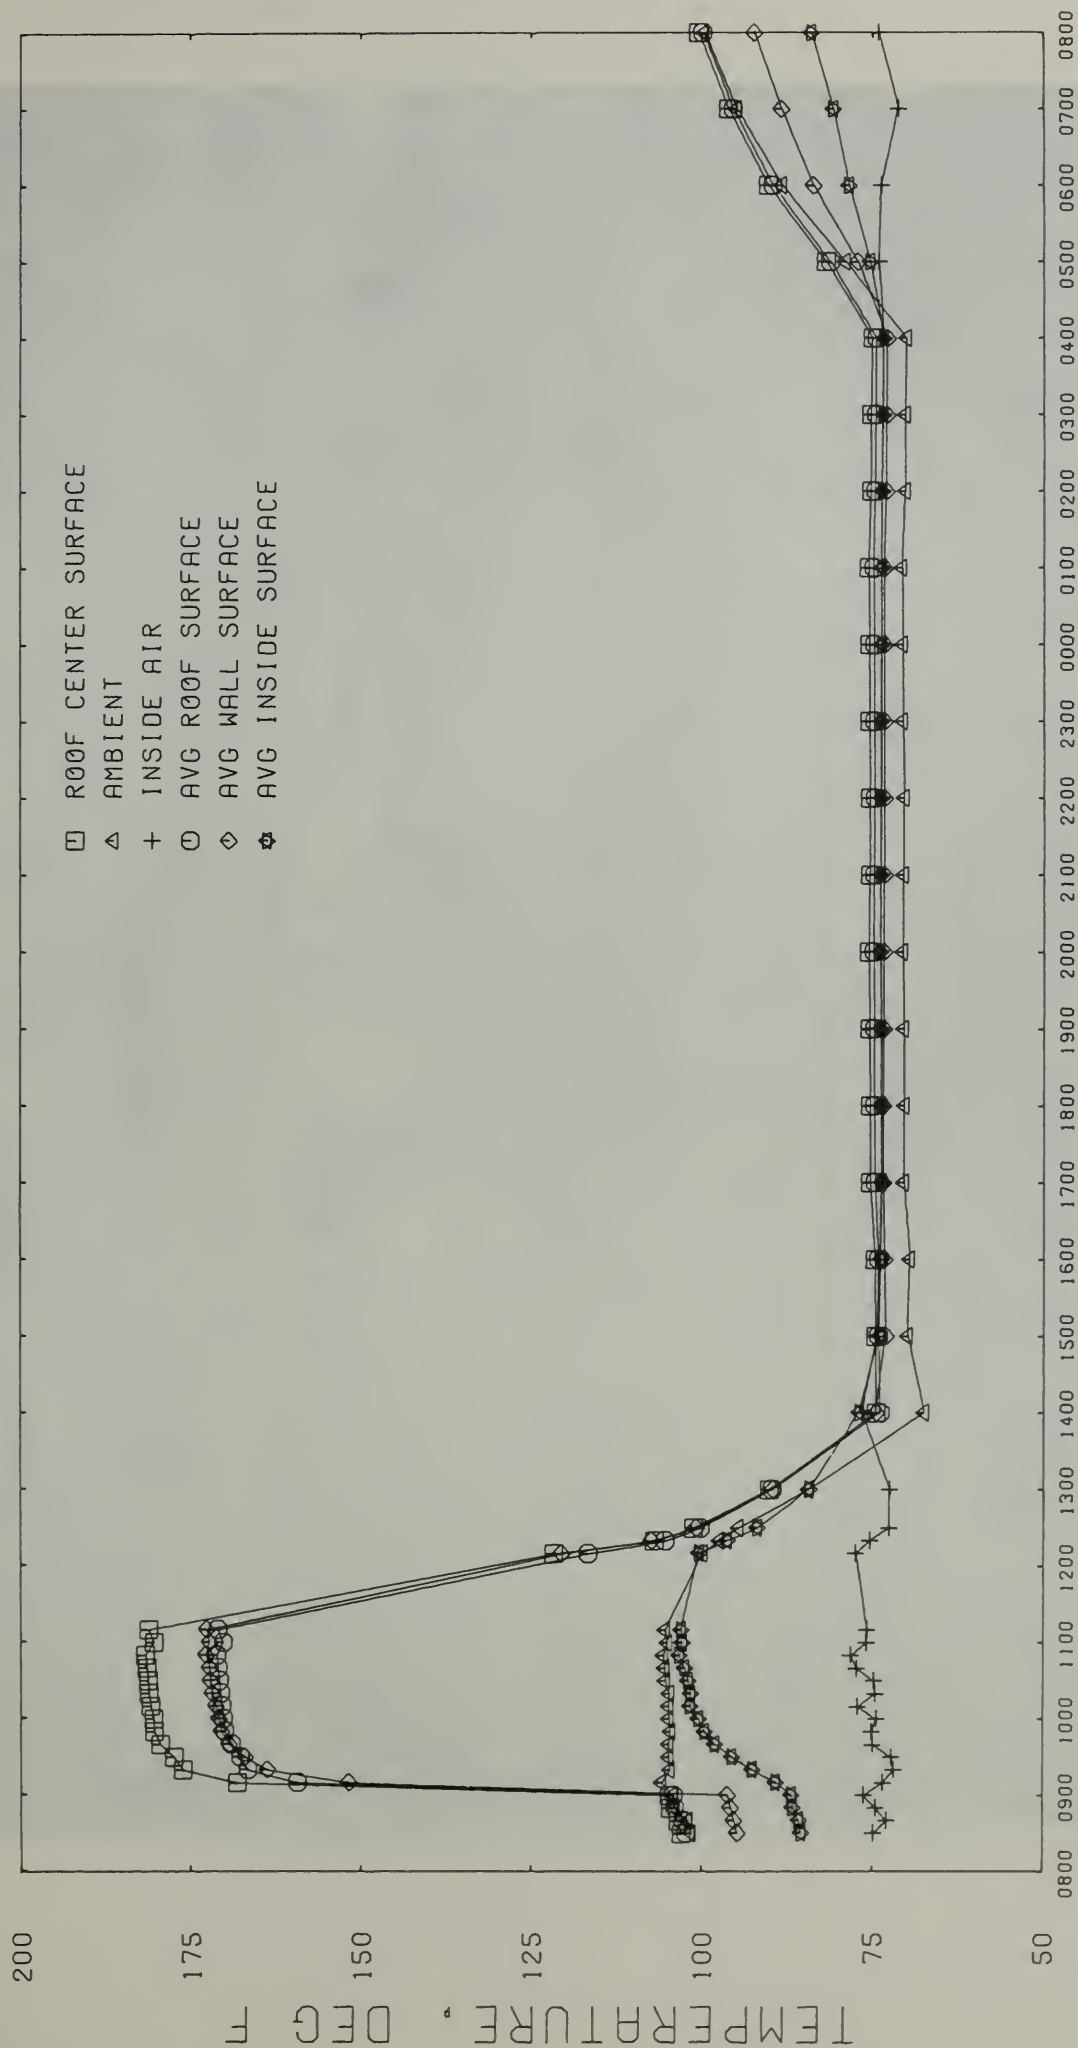
14 JULY, 1970 WARD B

Figure 7. Typical time-temperature data for one cycle on Ward B.

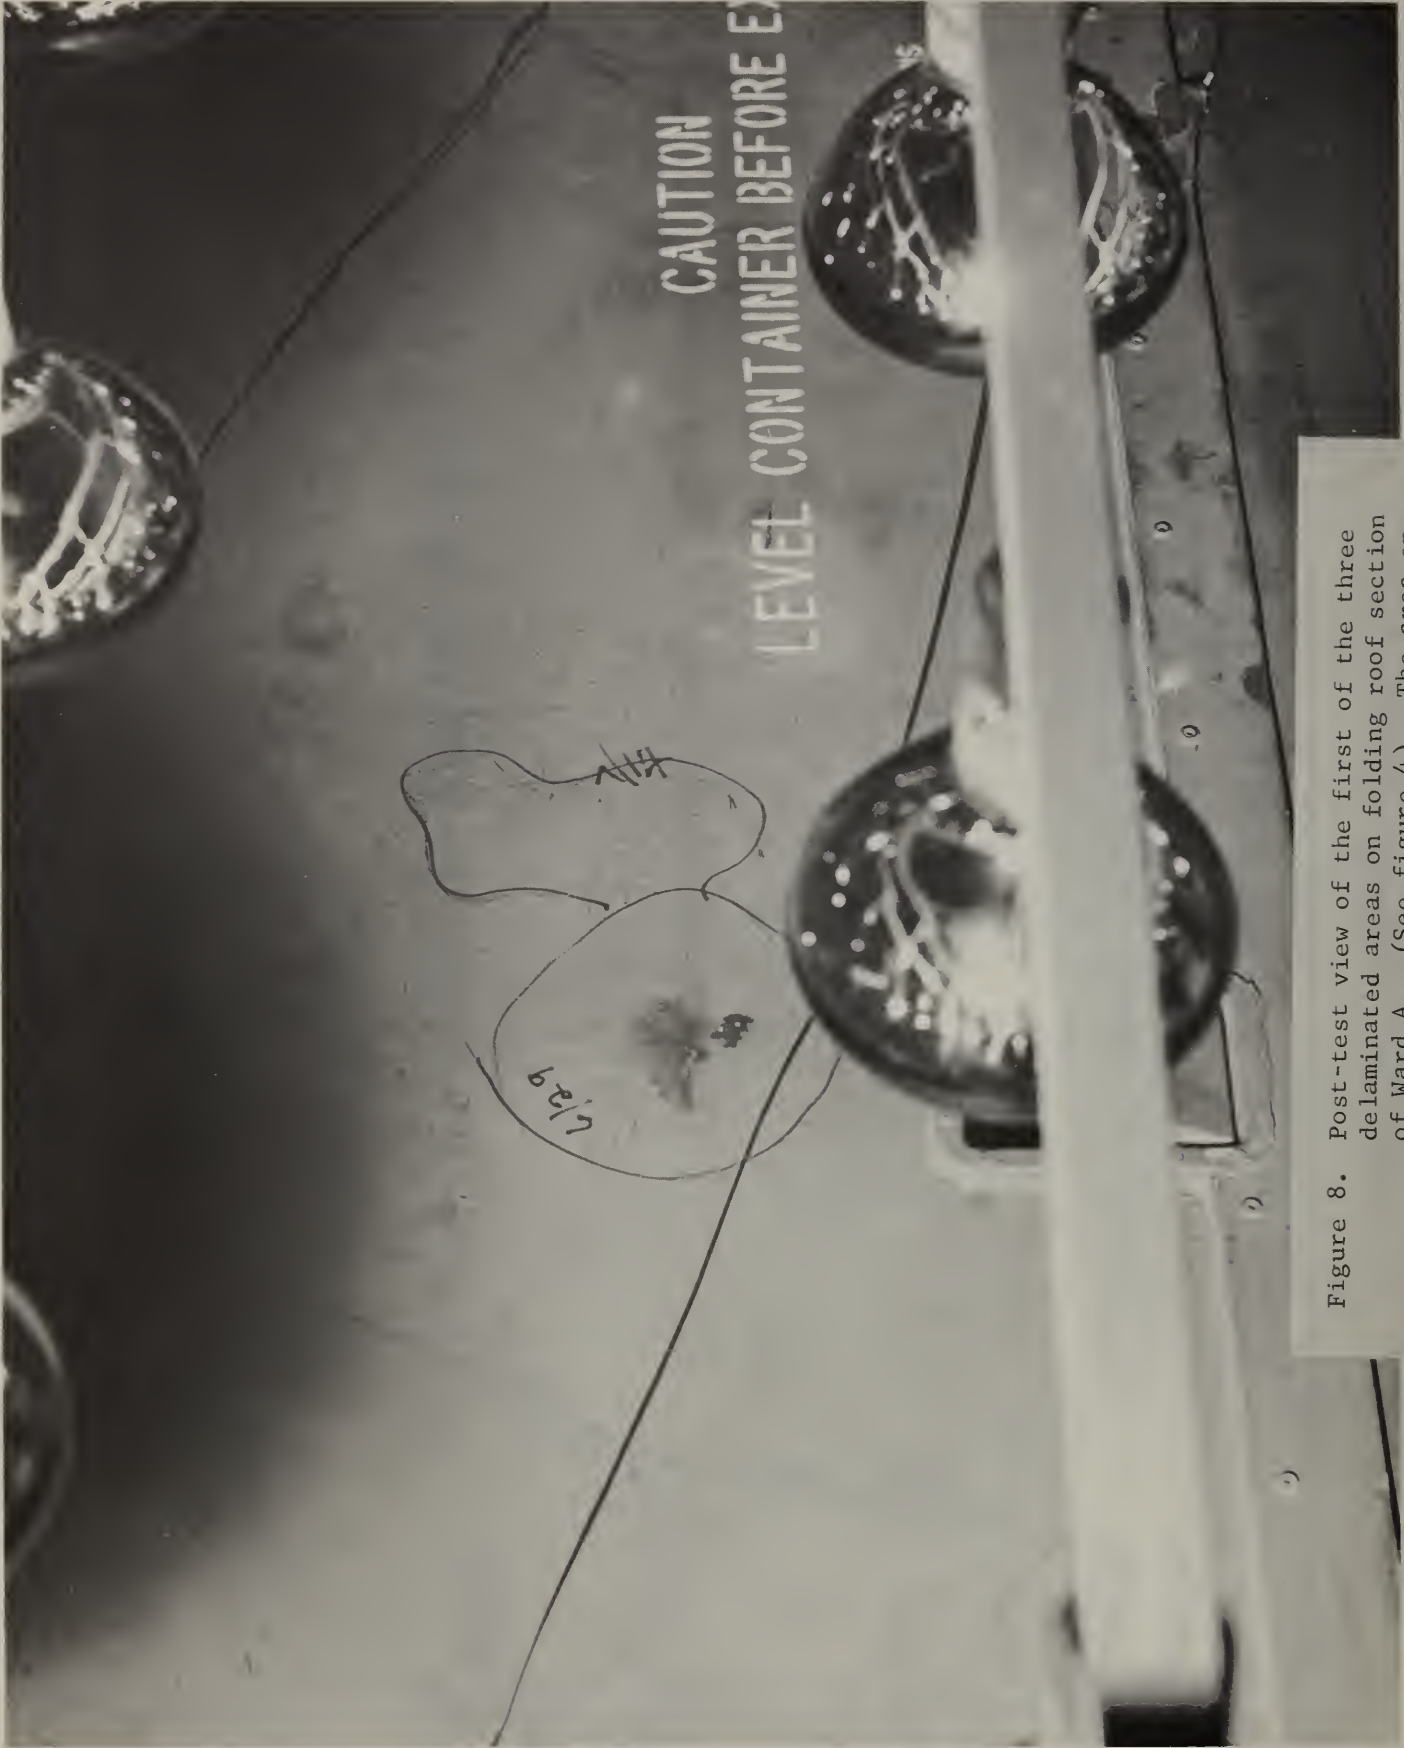
Figure 8. Post-test view of the first of the three delaminated areas on folding roof section of Ward A. (See figure 4). The area enclosed by the 6/29 circle was delaminated prior to test.

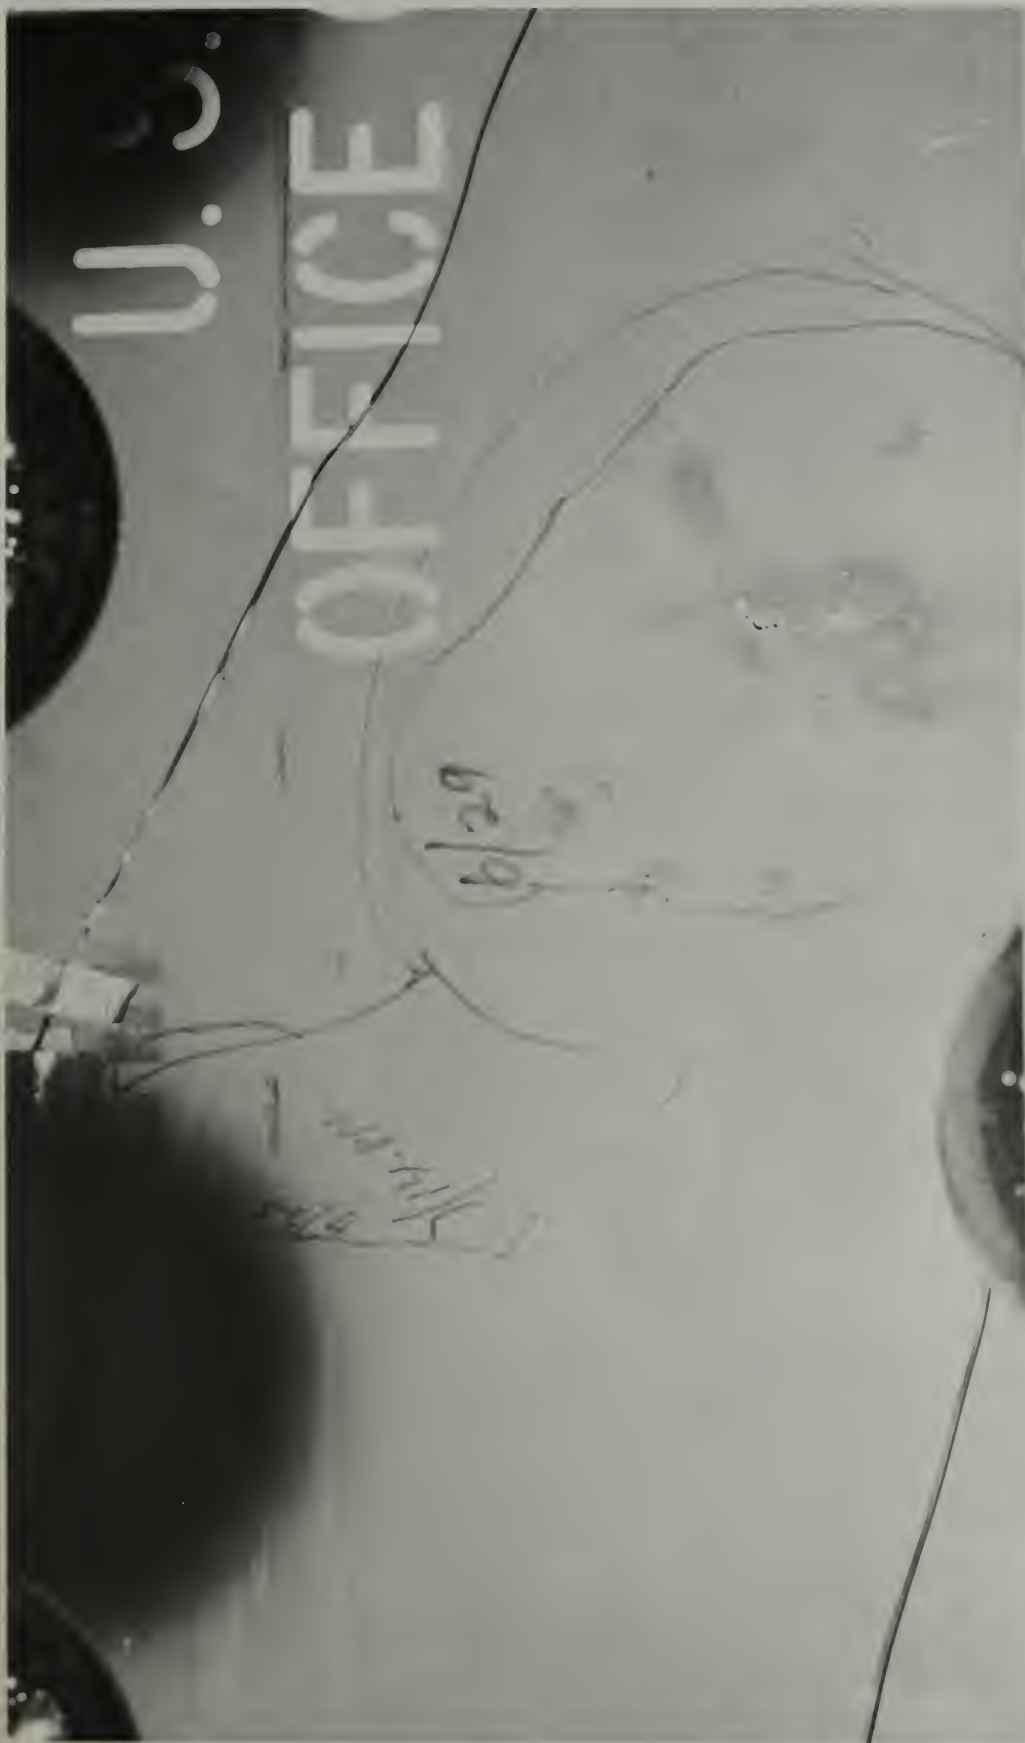
There were indications that the delamination at these two areas was caused by corrosion of the skins. The corrosion, which appeared to have started from the interior of the panel, had eaten all the way through the skin at the second of the two delaminated areas (see figure 9). These corroded areas were approximately opposite screw-inserts potted in the honeycomb core.

Figure 9. Post-test view of the second of three delaminated areas on folding roof section of Ward A. (See figure 4). The area enclosed by the 6/29 circle was delaminated prior to test.

It is evident from the above that the prototype ward, which had seen extensive use in the field with only minor delamination prior to laboratory testing, was clearly superior to the production ward in delamination resistance under temperature cycling. Two of the three delaminations which did occur in the prototype were apparently caused by a corrosive agent within the panel.
